Failure analysis of a degraded 1.2 kV SiC MOSFET after short circuit at high temperature

Failure Analysis of a Degraded 1.2 kV SiC MOSFET after Short Circuit at High Temperature

Paula Diaz Reigosa, Francesco Iannuzzo, Lorenzo Ceccarelli

Department of Energy Technology, Aalborg University, Pontoppidanstraede 111 DK-9220, Denmark

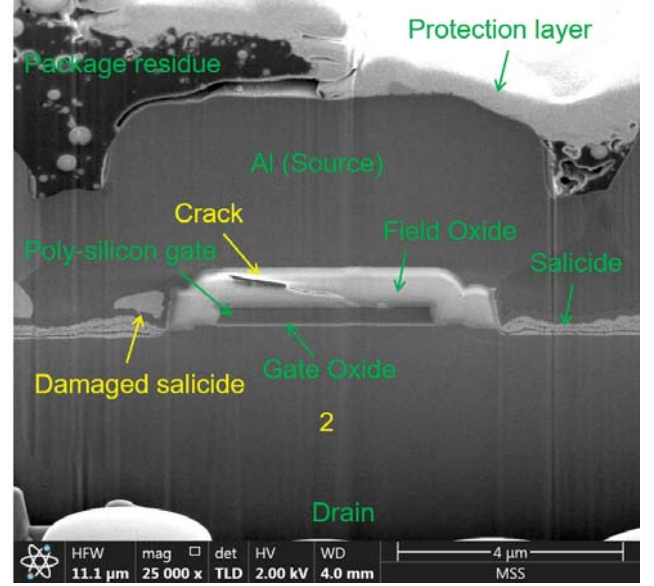
Furthermore, the salicide which is the technology that is used to form the electrical contact between the semiconductor substrate and the source terminal appears severely degraded, as pointed out in Fig. 5. This region is further magnified in Fig. 6, where it can be observed that solid particles accumulate in the aluminum source region between the salicide and the gate oxide. So far, the origin of these particles is not clear and it is not possible to provide the relevant information about the failure mechanism due to the short circuit stress. To better understand whether these particles may come from a process defect or could have originated after the applied short circuit stress, a cross-section of a new 1.2-kV/90-A SiC MOSFET will be presented in the next section.

Fig. 5. Magnified Focused Ion Beam (FIB) cross-section of the damaged cell.

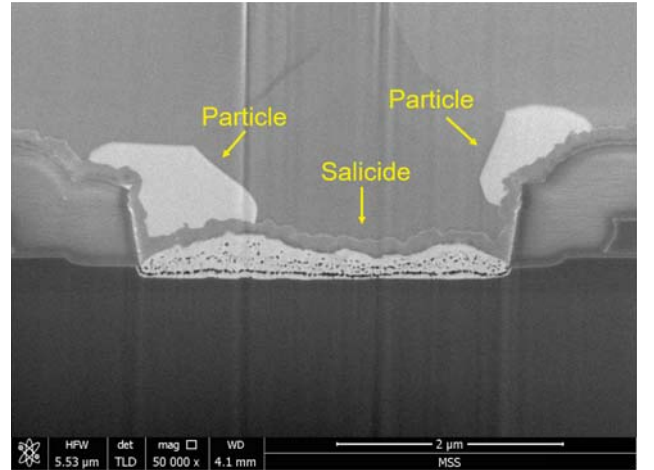
Fig. 6. Magnified Focused Ion Beam (FIB) of the salicide region of the degraded SiC MOSFET.
